DISMAL CONDITION OF WATER BODIES IN URBAN LANDSCAPE: A CASE STUDY ON SELECTED PONDS IN BURDWAN MUNICIPALITY, WEST BENGAL

Alokananda Ghosh & Biswaranjan Mistri

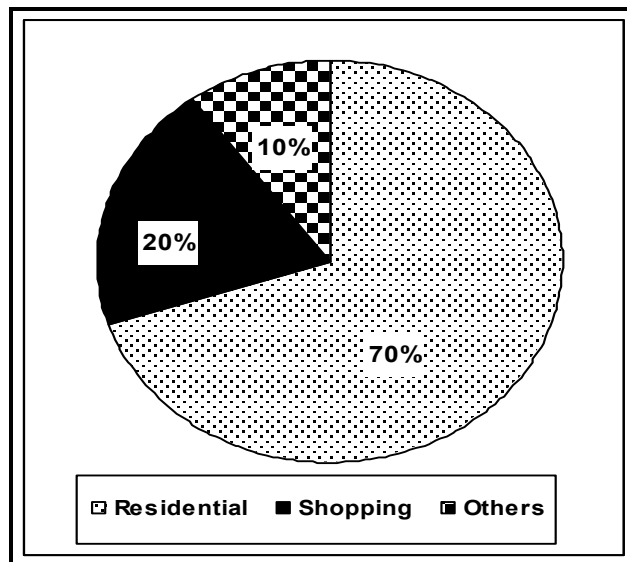
- The field survey portraying a picture about the Encroachment by the side of the ponds in the study area, mainly because of the residential purposes (70%), shopping purposes (20%) and others (10%), like in *Kamal Sayar* accept the eastern part, the other parts are occupied by settlement. In *Suli Pukur* the southern and western part are covered by settlement, whereas *Rani Sayar* is completely surrounded by households. As a result different factors are arising which are responsible for the deterioration of the water quality of the study area .

Figure 5. Encroachment by the Side of Ponds (Source: Field Survey, 2011)
(Figure 5 & 10)

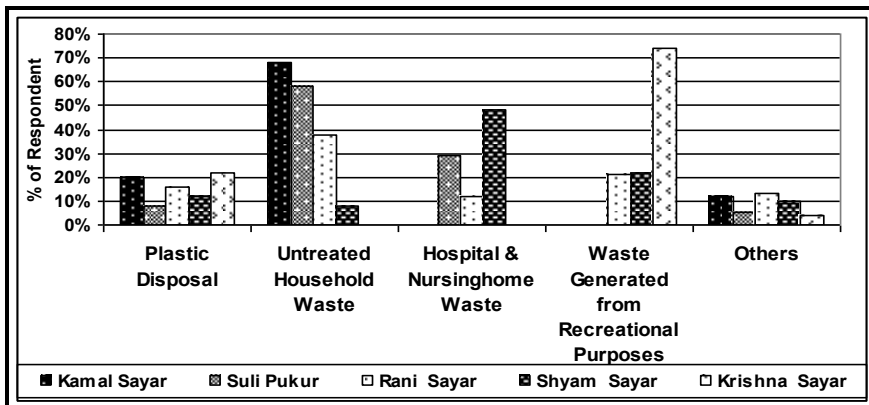
Figure8.

Factors Deteriorating the Quality of Water (Source: Field Survey, 2011)

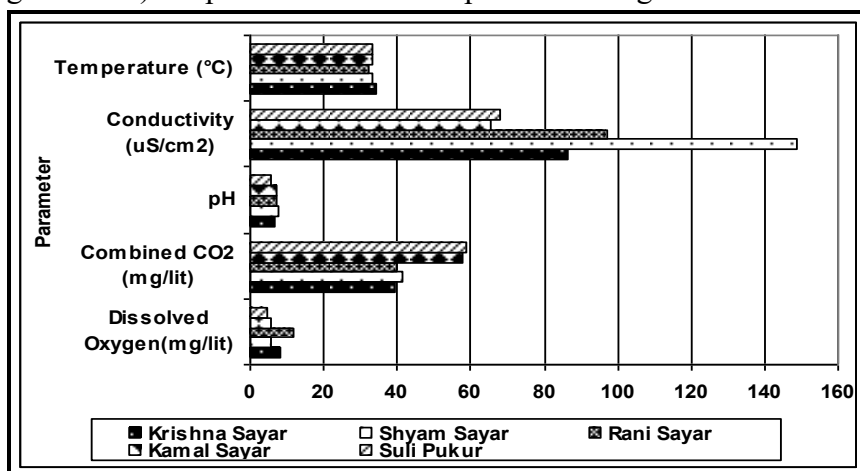
Figure 9.

The ponds are holding about 10 to 12 mg/L of oxygen, which is the stander of dissolved oxygen and good for fish and other aquatic life. The amount of conductivity is high (148.8 µs/cm²) mainly in *Shyam Sayar*; it is because of high detergent influx in the water as the clothes of the patients of Burdwan Medical College Hospital are being washed here. Its value depends upon presence of total concentration of ionized substances. The amount of Combined CO₂ is maximum in *Suli Pukur* (58.6665 mg/litre), creating a harmful environment for the fishes. In general most fishes can do better in ponds with a pH near 7.0. So here it could be said that all of them are suitable for pisciculture except *Suli Pukur* (pH 5.5), though during study the variation of pH showed no reasonable significance. According to WHO (World Health Organization) the permissible limit of pH in drinking water is 6.5-8.5.

Quality of Water Tested in Laboratory

The conductance shows the measures of concentration of mineral constituents in the water. The value depends upon the total concentration of ionized substances in the water shows that the conductivity is highest amongst the five in *Shyam Sayar*, as the total dissolved solid is high in this pond, which is the contribution of nearby Burdwan Medical College and Hospital and the various pathological centers. The permissible limit of Dissolved oxygen in average 35°C temperature is 6mg/litre, less than 6mg/litre can have detrimental effect on aquatic life, whereas in case of pH, the range is between 7.0 to 8.5 . Temperature is not as that much important factor to be considered in this situation but the aquatic herbicides are most effective when temperatures are between 15.5°C to 23.8°C. The total concentration of CO₂ changes periodically, but the concentration of CO₂ >20 mg/litre can have adverse effect on the water quality.

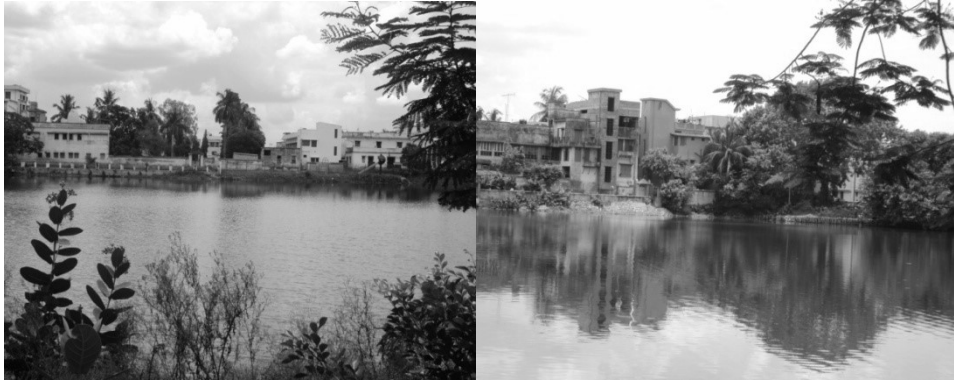
Figure 10. Encroachment by the side of Shyam Sayar (left side photo) and side of Rani Sayar (right side photo) due to rapid urbanization

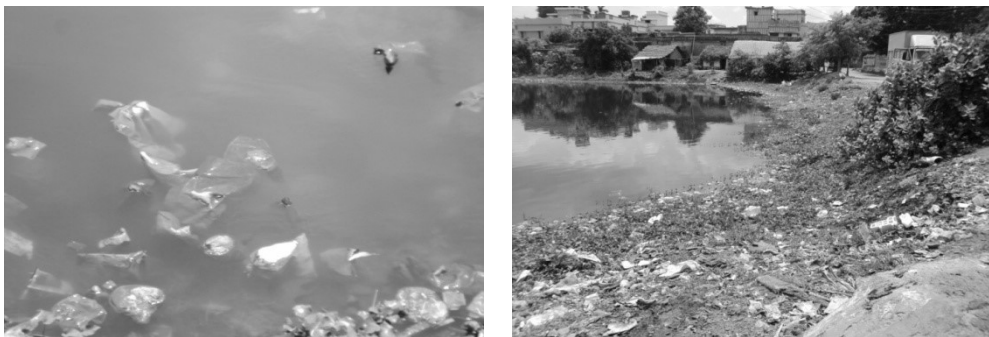
Figure11 . Deterioration of water quality due to solid waste disposal like floating plastics and bottles (left side photo) and other household and bio-medical wastes (right side photo)

Amongst these, ward number 30, side of Rani Sayar and Shyam Sayar generate maximum amount of solid waste. Burdwan Medical College and Hospital is mainly responsible for the bio-medical waste near the Sayar, as well as major share of these solid wastes is come from a number of nursing homes, pathological laboratories and doctor's private chambers. (Figure 11)

The quality of water in Krishna Sayar is affected badly due to solid waste disposal, mainly during the time of Basanta Utsab and Fool Mela, because of the disposal of plastic, bottles, polythene, plastic containers, straw, paper, fruits and vegetables etc.

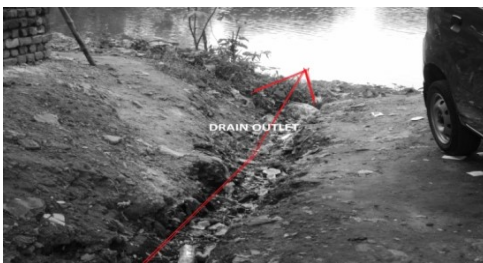
Figure 12 . The discharge of the household waste and the sludge from the septic tank of the surrounding household as the Household and roadside drain are opening to the pond

- The discharge of the household waste and the sludge from the septic tank of the surrounding household, creating serious problem by putting the ground and the surface water at a great risk of being polluted by pathogens, hazardous chemical sand nutrient such as phosphorus, nitrate and organic wastes, resulting eutrophication.
- In some area the garbage are thrown indiscriminately at the side pond near the drinking water source, as a result ground water is also gets polluted through the leaching of the pollutant from the dumping source.
- These garbage points are the breeding point of the mosquitoes, flies, and various insects, causing serious diseases. During the rainy season the garbage from the Municipal garbage point washed out to the nearby pond and degrades the water quality of the pond, causes skin disease to the human body.

▪ Drainage problems are the most common. The surrounding household having their drain outlet mostly in the ponds; like in the western and northern part of *Kamal Sayar*, 26 and 12 household allowing their household drain to open to the pond, the same scenario has been seen in *Suli Pukur* and *Rani Sayar*
